# UNDERWATER BRIDGE INSPECTION REPORT

STRUCTURE NO. 57501

RED LAKE RIVER

PREPARED FOR THE  
MINNESOTA DEPARTMENT OF TRANSPORTATION  
BY  
COLLINS ENGINEERS, INC.  
JOB NO. 3512 (CEI 162)

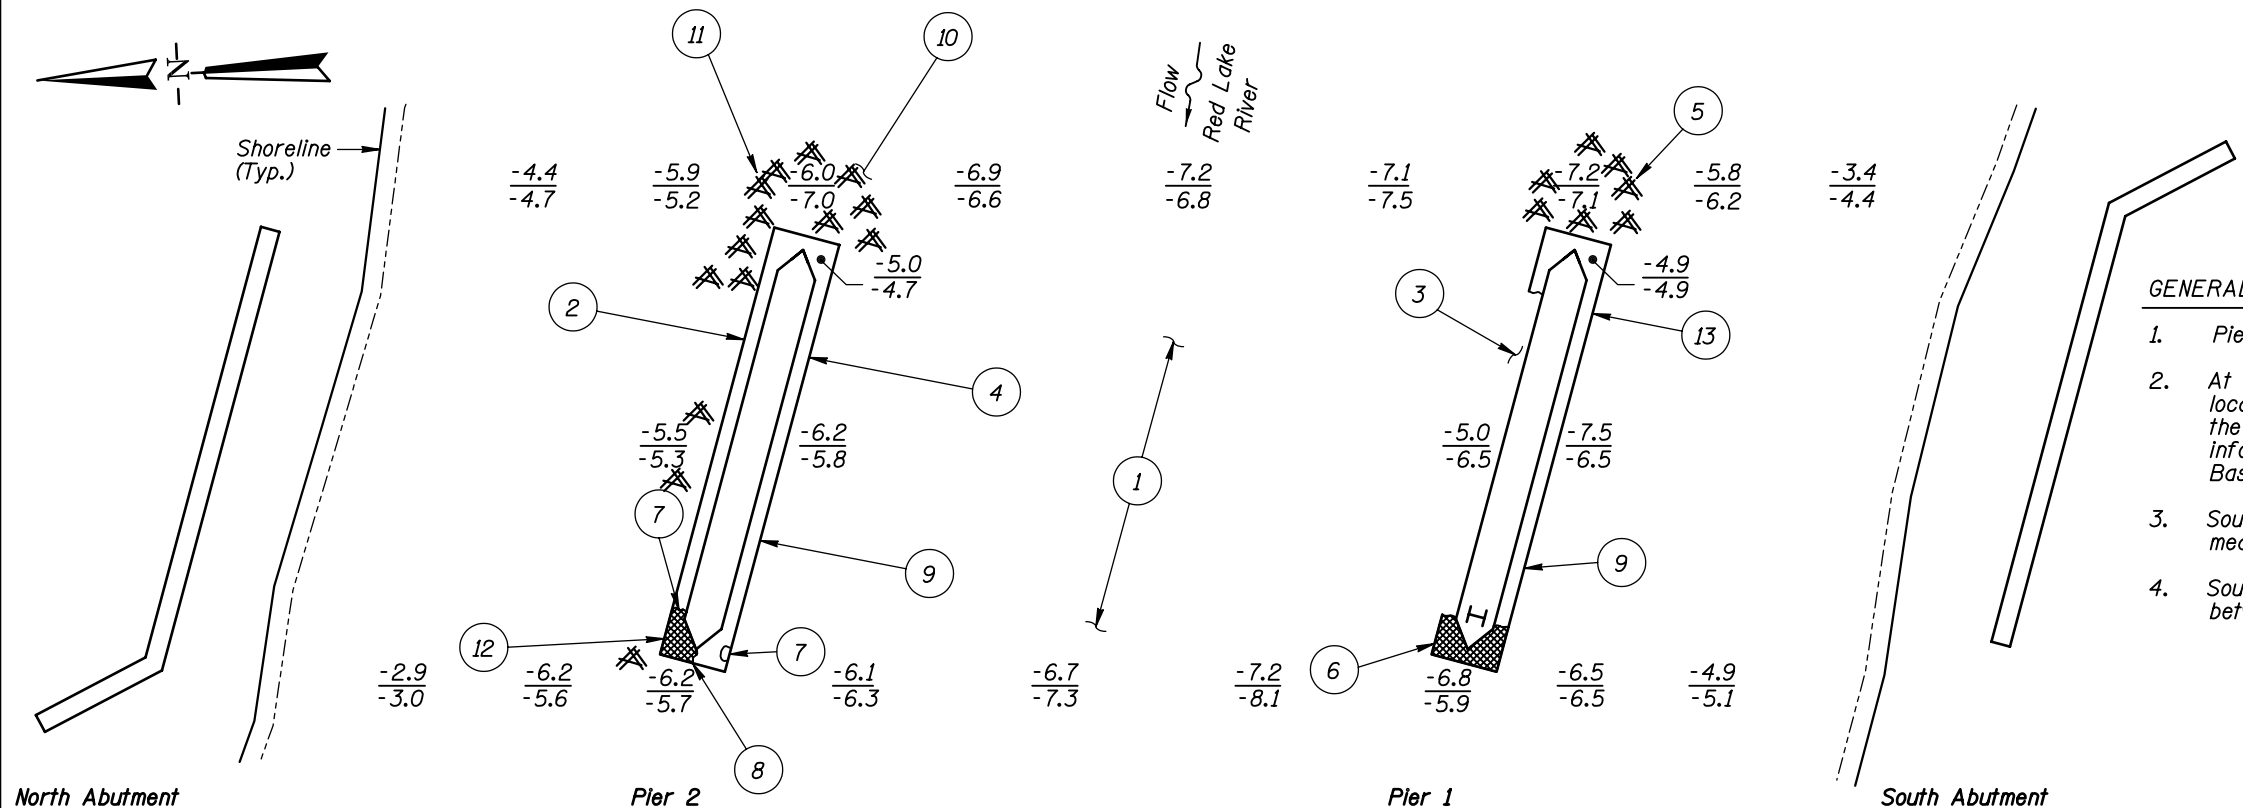
- The channel bottom material consisted of silty sand and gravel with scattered 6 to 8 inch diameter cobbles and up to 3 inches of probe rod penetration.

- The top of the enlarged bottom portion (stepout) of concrete shaft and up to 6 inches of the vertical face was exposed along the north side of the pier.

- Enlarged bottom portion of concrete shaft which was exposed during the previous inspection has since been covered with soft silty sand infilling with 1 foot of penetration along the north side of the pier.

- 9 inches of vertical undermining was observed at upstream nose and along 6 feet of the south side of the pier exposing several steel H-piles with light surface corrosion. The middle portion of the south side of the pier exhibited 2 to 3 inches of vertical undermining with typical probe rod penetrations of 6 inches and a maximum of 1 foot. The downstream end of the pier exhibited up to 9 inches of vertical step face exposure with no undermining.

- A light to moderate accumulation of vegetation and organics with 6 inch timber debris was observed from the waterline to the channel bottom and radiating 5 feet from the upstream nose of the pier.

- The bottom portion of the shaft (stepout) was broken off at the downstream end exposing three corroded horizontal steel reinforcing bars. The broken piece of the step was lying on the channel bottom and was approximately 3 feet long.

- A horizontal crack was observed along the top of the shaft step, 6 inches wide with 4 inches maximum penetration, extending from the shaft nose to edge of step.

- A spall was observed at the downstream end of the shaft step, 6 inches wide with 4 inches maximum penetration, extending from the shaft nose to the edge of the step.

- The concrete of the bottom portion of the shaft (stepout) was frequently soft on the surface with random irregularities and section losses having up to 5 inches of penetration.

- Riprap was observed on the channel bottom measuring 1 to 2 feet in diameter.
- A light to moderate accumulation of timber debris was observed around the upstream nose from 3 feet below the waterline to the channel bottom with branches up to 3 inches in diameter.

- The shaft bottom step was cracked and detached at the northern downstream end of the pier between the two noted cracks.
- 6 inches to 1 foot of vertical undermining was observed at the upstream nose and along 5 feet of the south side of the pier exposing several steel H-piles with light surface corrosion. The middle portion of the south side of the pier exhibited 2 to 3 inches of vertical undermining with typical probe rod penetrations of 6 inches and a maximum of 1 foot. The downstream end of the pier was level with the channel bottom with 3 inches of maximum vertical step face exposure along the downstream sides of the pier.

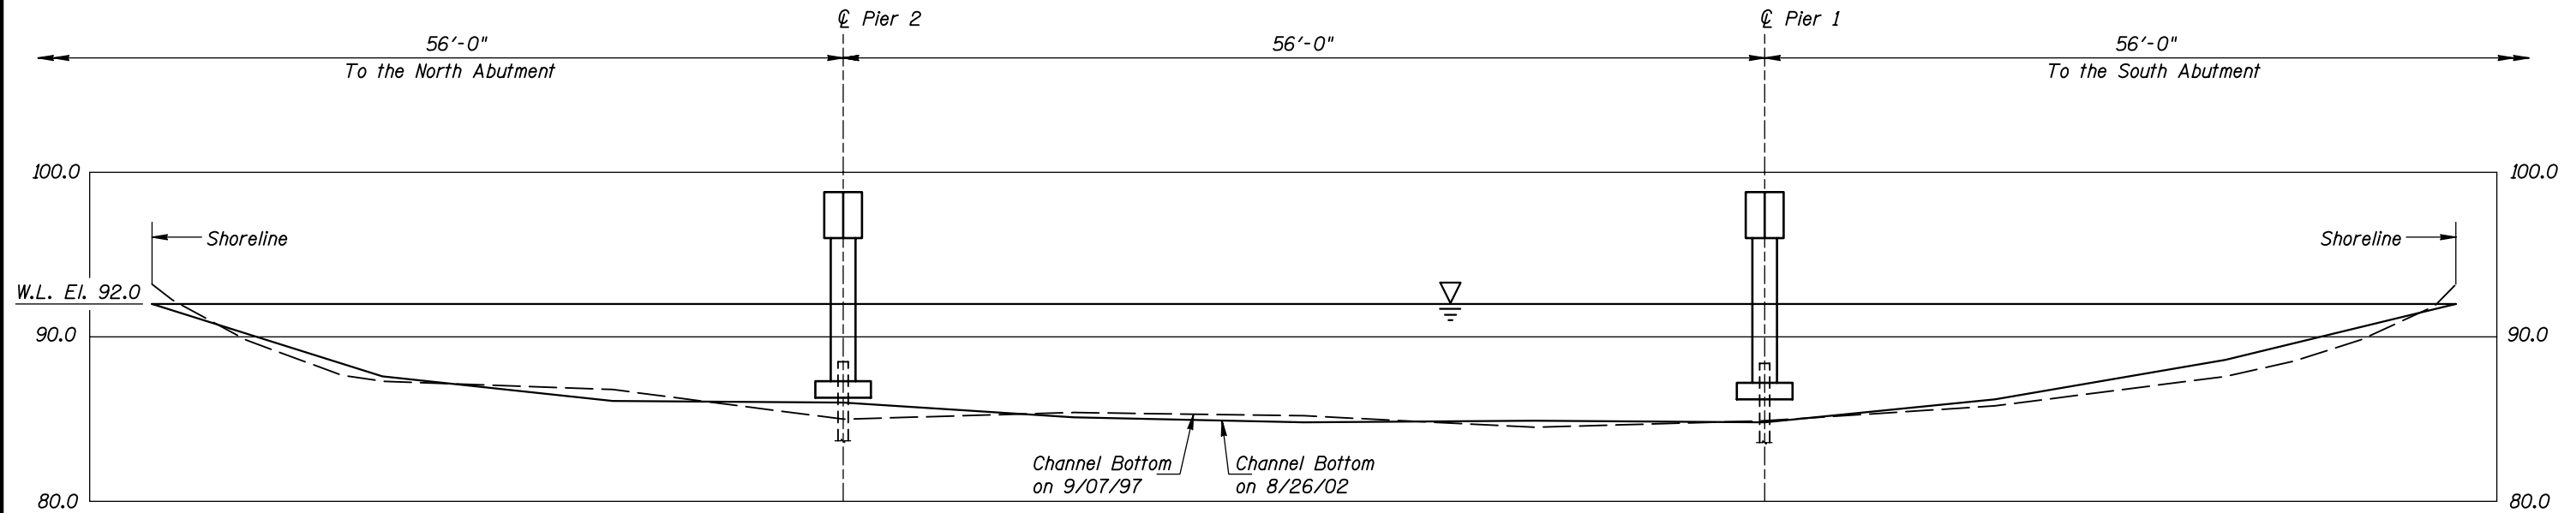
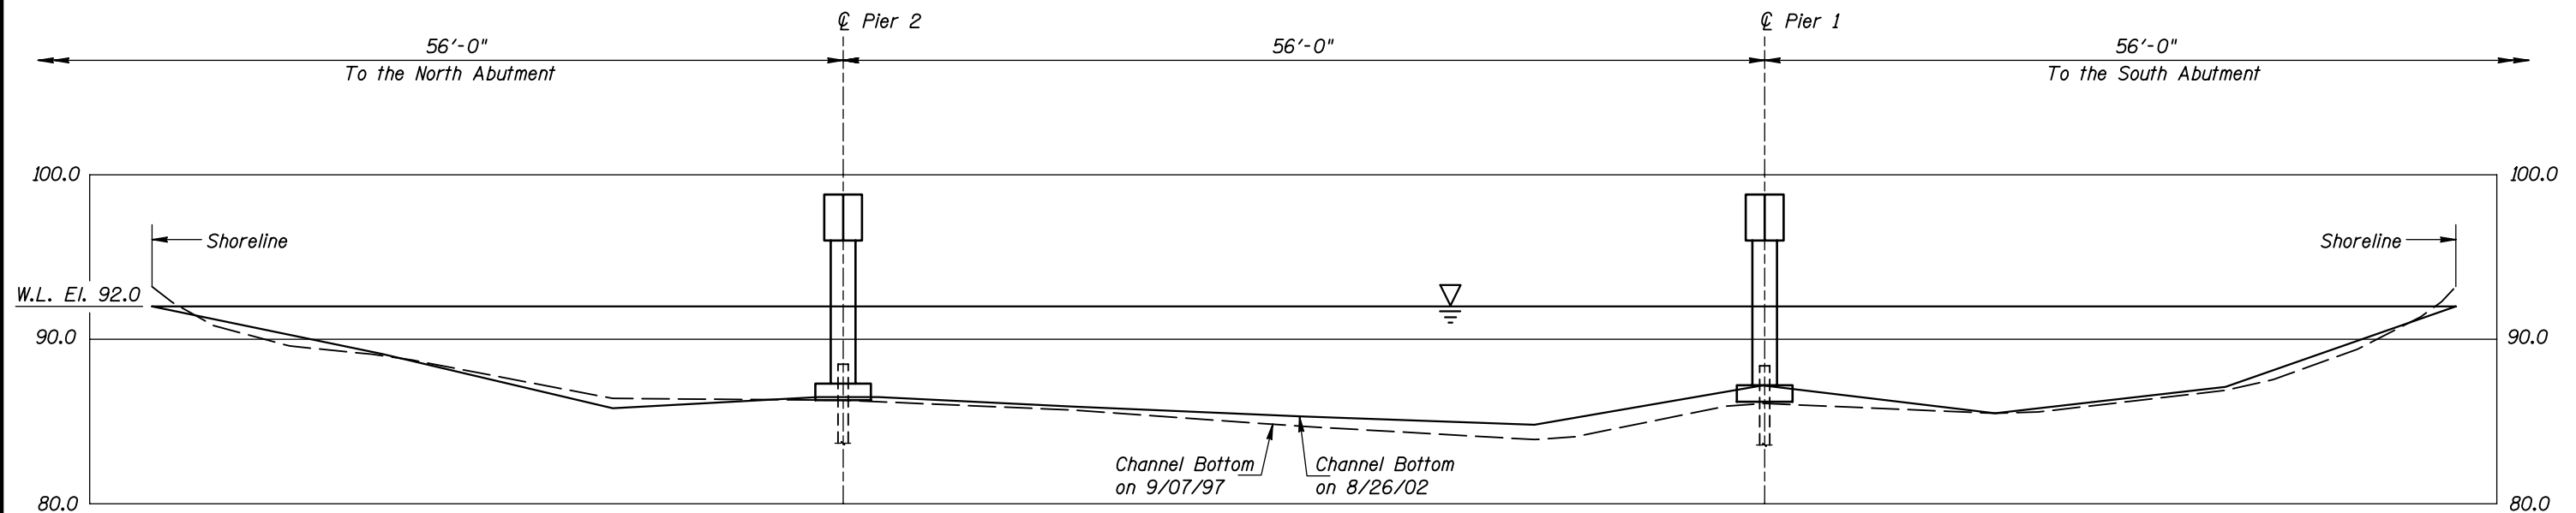
Date: AUG. 2002  
Scale: 1"=10'  
Figure No.: 2

UPSTREAM FASCIA PROFILE

DOWNSTREAM FASCIA PROFILE

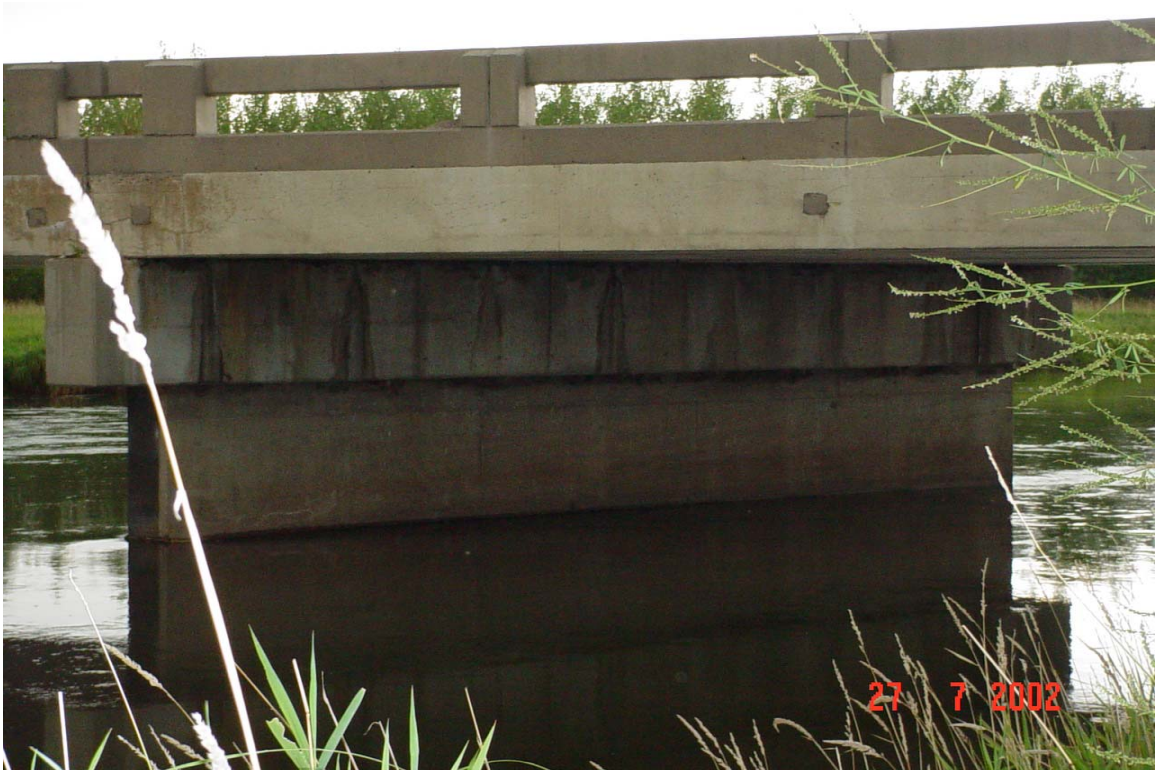
Photograph 1. View of Pier 2, Looking Southwest.

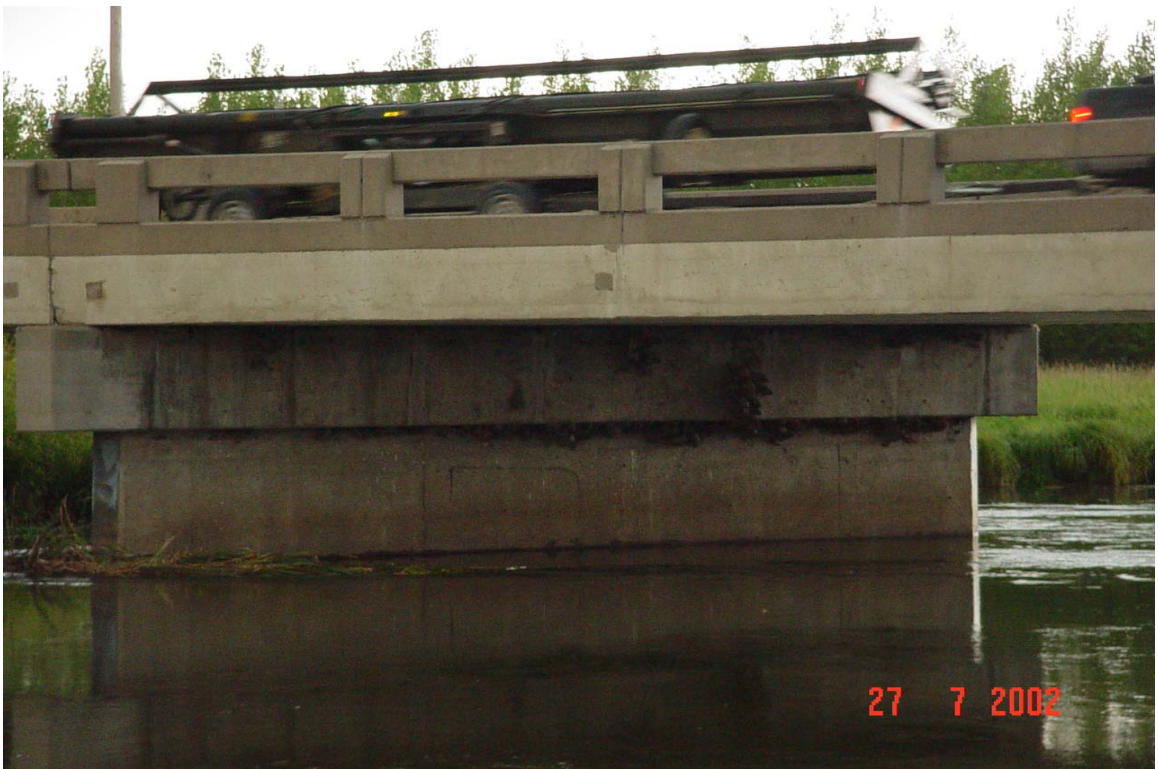
Photograph 2. View of Pier 1, Looking Southwest.
